CAESAR CREEK LAKE
LITTLE MIAMI RIVER BASIN
OHIO

EMBANKMENT CRITERIA AND
PERFORMANCE REPORT

PREPARED BY
U.S. ARMY ENGINEER DISTRICT, LOUISVILLE
CORPS OF ENGINEERS

SEPTEMBER 1982

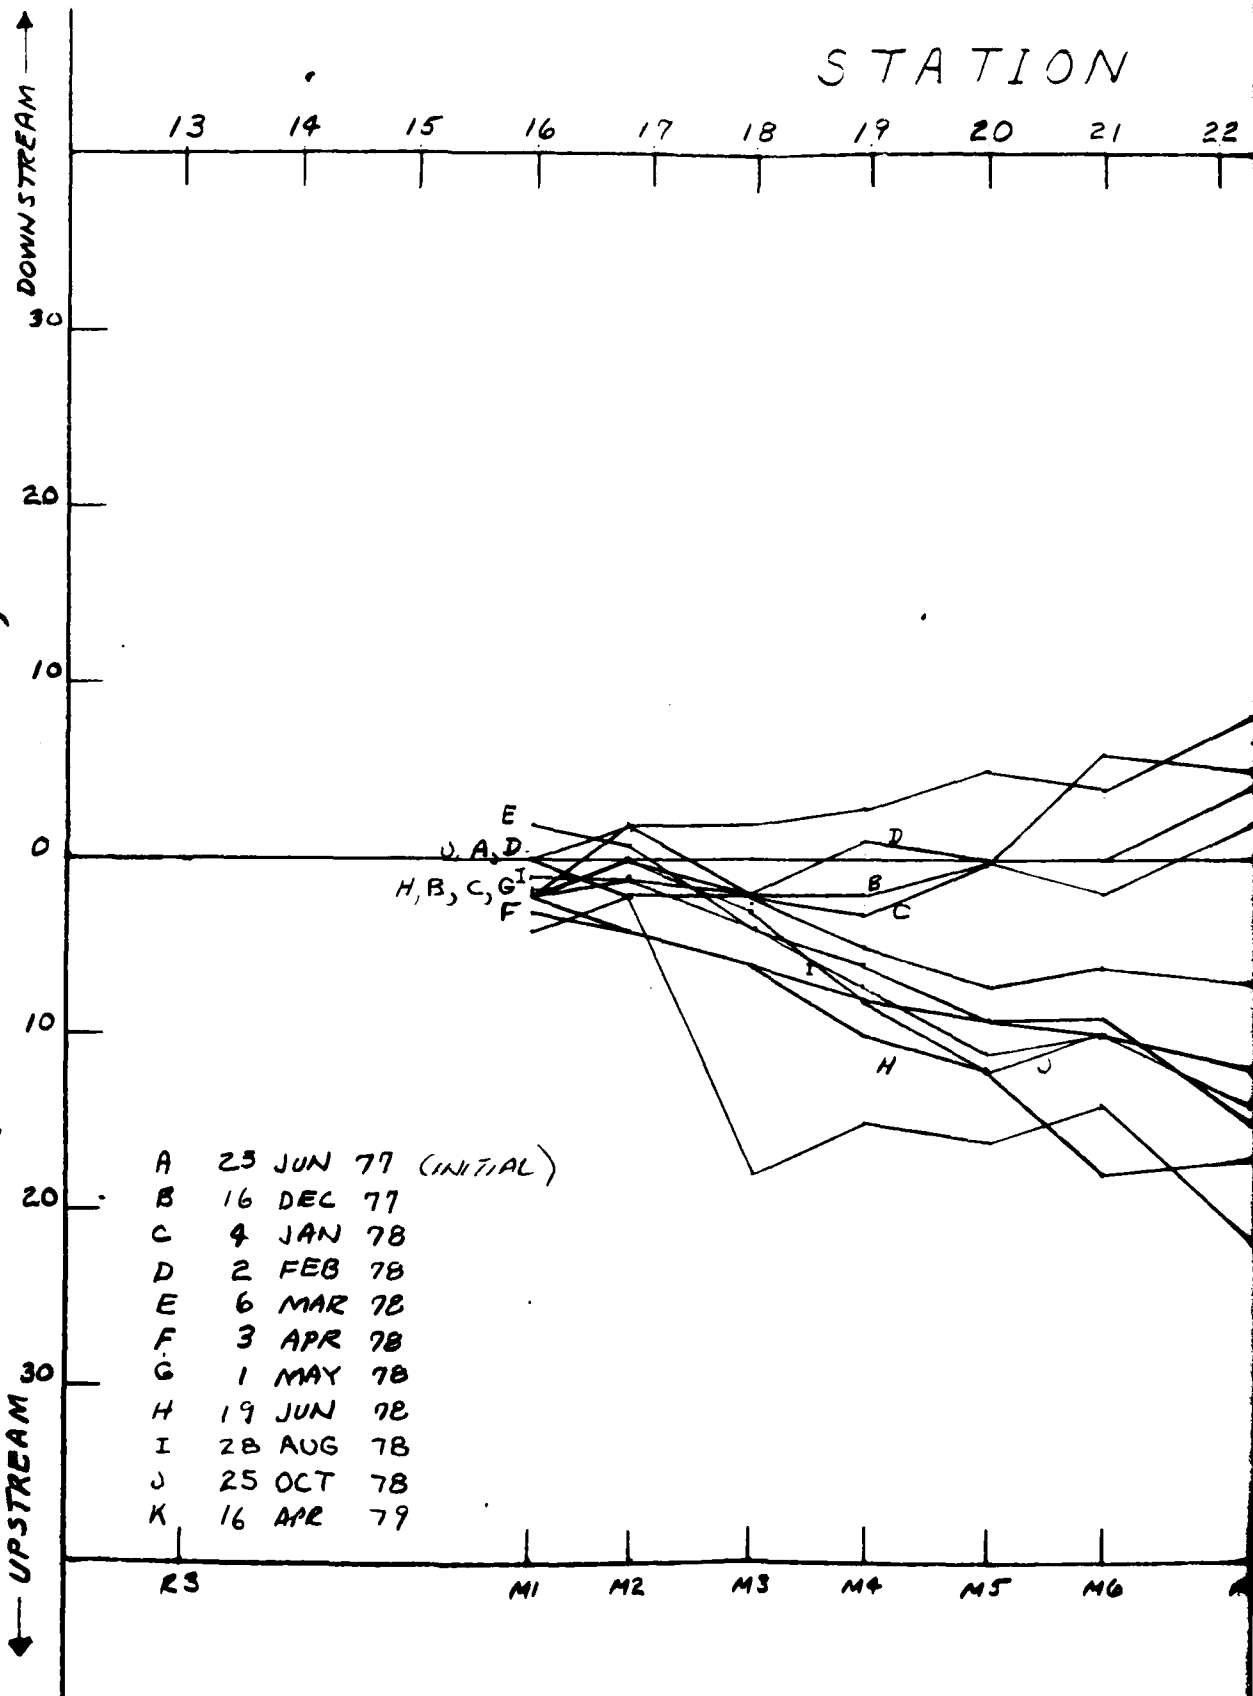
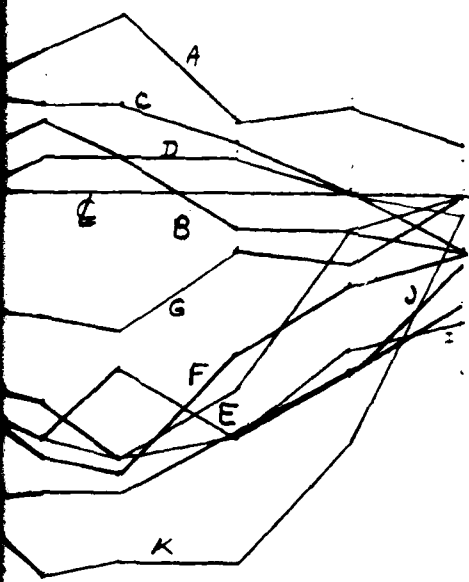
PLATE 43

HORIZONTAL CUMULATIVE MOVEMENT (HUNDRETHS OF A FOOT)

CAESAR CREEK
MOVEMENT MARKERS
20' D.S. &
HORIZONTAL MOVEMENT

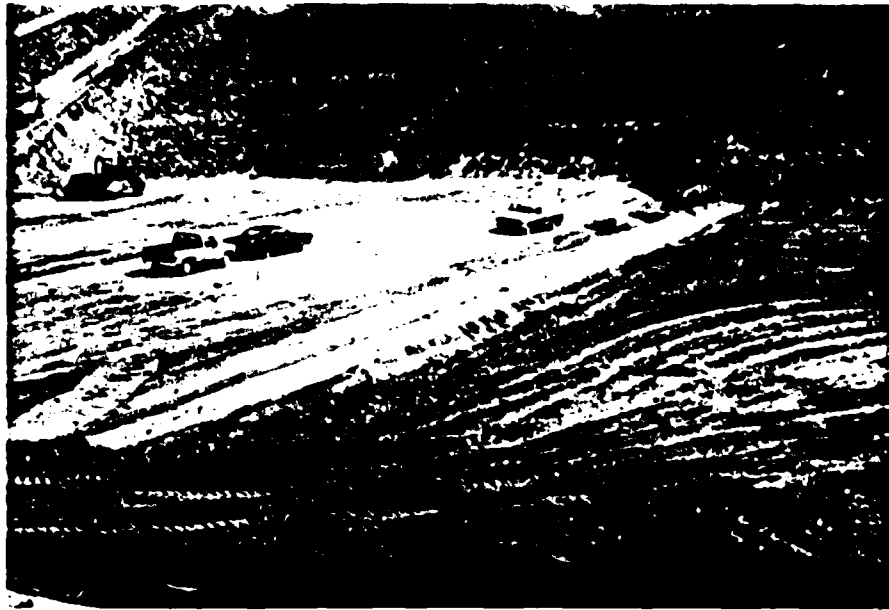
- (9) View looking at left abutment toe of dam showing beginning of 5 foot wide transition zone and 5 foot wide inclined drain. Material right-hand lower corner of photo is top of original sand and gravel which remained in place. 19 Sep 1974.

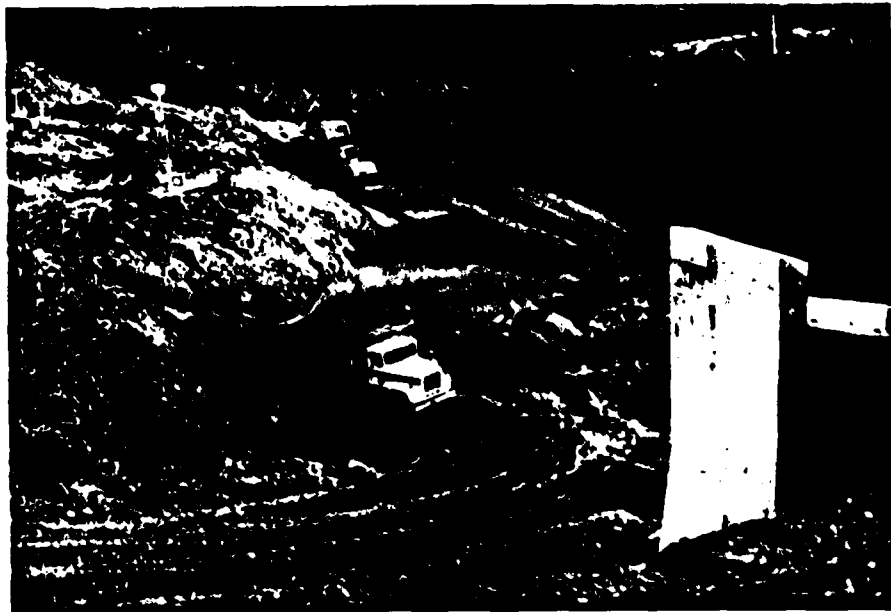
- (10) Horizontal sand drain being placed at downstream toe of dam. Nov 1974.

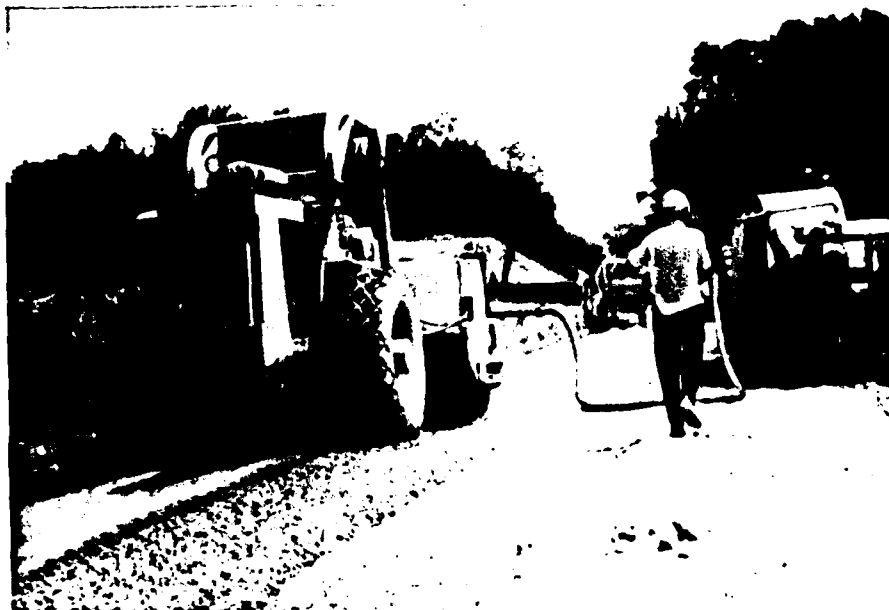
(13) Spray bar and water supply wagon used to add moisture to transition material. June 1975.

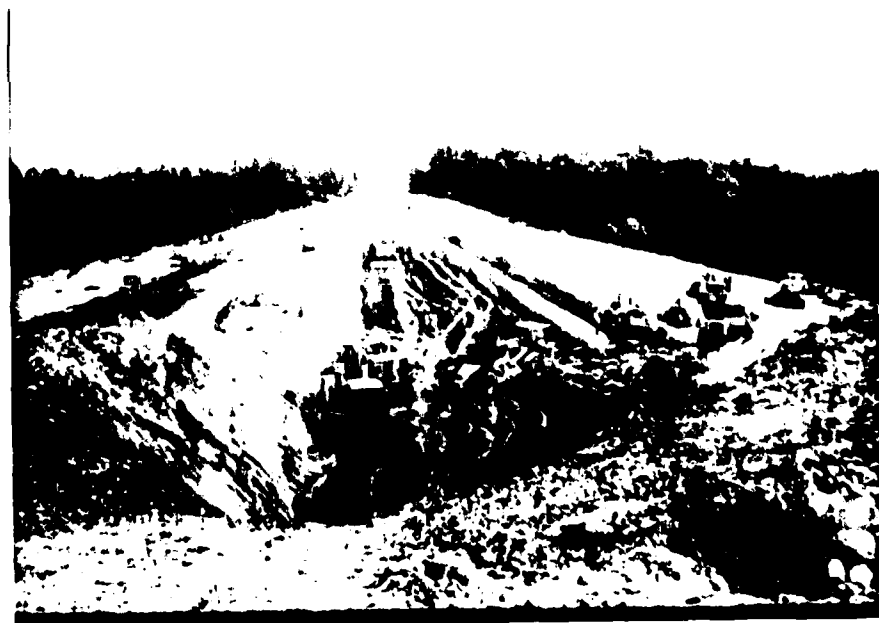
(24) General view of construction operations looking from right abutment. June 1975.

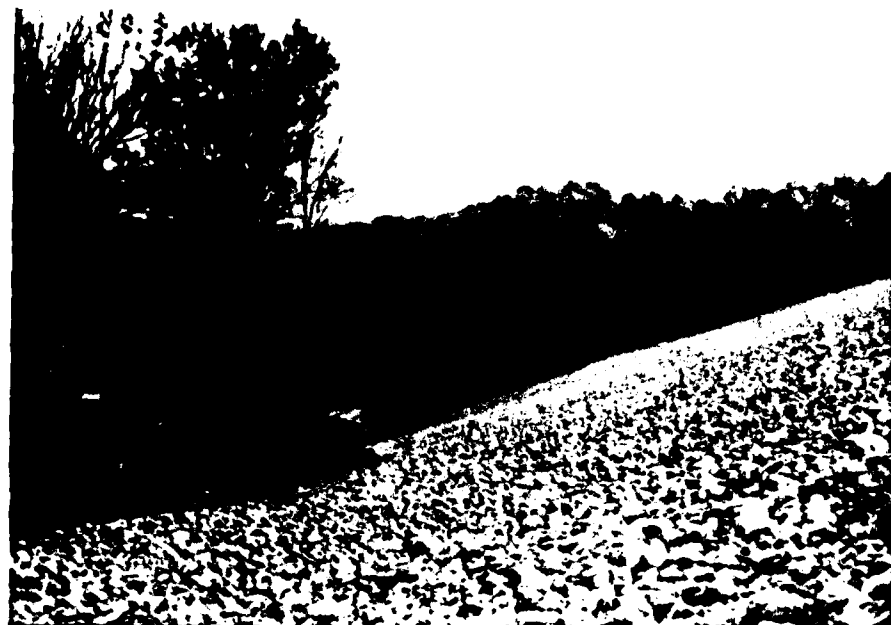
(25) View from right abutment to left abutment across upstream face of dam showing placed riprap. 4 Oct 1975.
